PROCEEDINGS

OF THE MARINE SAFETY COUNCIL

Seawitch-Esso Brussels	86
----------------------------------	----

The following narrative account was extracted from the Marine Casualty Report (No. USCG/NTSB-MAR-75-6) released 2 March 1976. Single copies of the complete and detailed report may be obtained without charge by writing to the Commandant (G-MVI-3/83), U.S. Coast Guard, Washington, D.C. 20590. Multiple copies may be purchased by mail from the National Technical Information Service, U.S. Department of Commerce, Springfield, Virginia 22151.

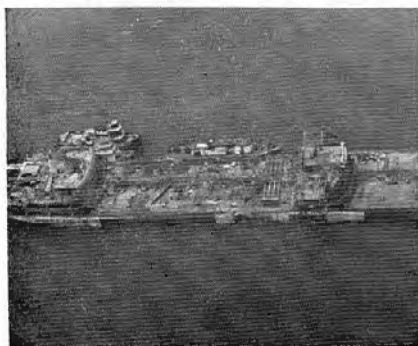
Esso Brussels

The bow of the *Sea Witch* penetrated the side shell in way of Nos. 7 and 8 starboard tanks severing No. 8 cargo tank top and the starboard king post of the *Esso Brussels*. The athwartships bulkhead separating Nos. 7 and 8 starboard tanks collapsed. The longitudinal bulkhead separating No. 8 starboard tank and No. 8 center tank was penetrated approximately 15 feet by the bow of the *Sea Witch*, allowing cargo from that tank to have free communication to the sea. The rupture of Nos. 7 and 8 starboard tanks and No. 8 center tank allowed approximately 31,000 U.S. barrels of cargo to be spilled and provided the initial fuel for the resulting fire. In addition approximately 1,000 U.S. barrels of cargo from the remaining cargo tanks were consumed in the fire.

Flames from the burning oil on the water ignited exterior paint and exterior combustibles. The resultant heat from the fire ruptured piping, melted brass components in ventlines and steam smothering lines, burned tank fitting gaskets which permitted the rapidly expanding vapors to escape and ignite contributing to the severity of the deck fire. The interior of both deckhouses was paneled with a pressed wood panel board which offered little resistance to the spread of fire. The engine room and lower levels of the pump room did not burn. The fire effectively consumed nearly all combustibles on and above the weather deck level and caused severe fire damage to those areas of the after

After the fire was extinguished, asbestos material was used to seal tank tops and ullage and tank cleaning openings where gasket material had burned out. Flame screening material was used over severed and burned away piping to insure flame tightness of cargo tank boundaries. Wooden plugs were used to seal other pipe openings not required for tank venting. Offloading of the remaining cargo was accomplished through the vessel's existing piping by the use of a steam-driven stripping pump located in the pump room. An undamaged pump room cargo riser was used to transfer the cargo to the main deck level where cargo hoses were used to offload the cargo to barges alongside. The ability to use the stubs of the burned off valve stems protruding from the packing glands to open and close valves made possible the use of the vessel's internal cargo piping for the cargo transfer. Upon completion of the offloading the *Esso Brussels* was gas freed and a preliminary damage survey was started.
